MULTITEMPORAL 3D MODELLING FOR CULTURAL HERITAGE EMERGENCY DURING SEISMIC EVENTS: DAMAGE ASSESMENT OF S. AGOSTINO CHURCH IN AMATRICE (RI)

KEY WORDS: UAV photogrammetry, multi-temporal model, structural assessment, seismic emergency, Cultural Heritage

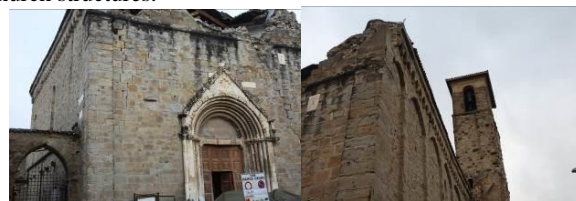
Figure 3. Two terrestrial images acquired in the first campaign

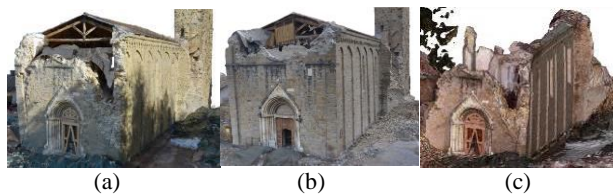
Figure 6. A view of the achieved models: September (a), December (b), January (c)

The achieved accuracy (Table1) allow considering the products suitable for a representation at a scale 1:100. In Figure 6 the achieved 3D models according to the different acquired dataset are reported.

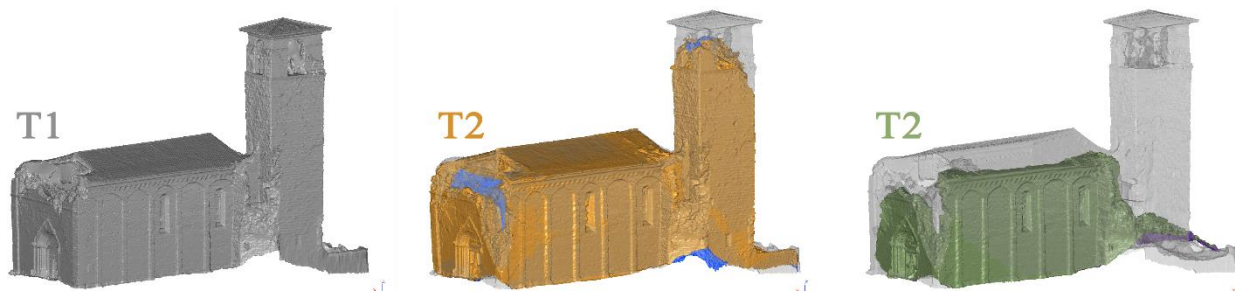
In Figure 8 a volumetric evaluation on collapsed structures; t1 model, alone (left) and compared to t2 and t3. The collapses caused by seismic shock and consequent loss of structural stability have led to significant loss of volume, up to -68,4% in comparison with the time 1, September 2016.

Figure 8. Multi-temporal model compared with t1

The main challenge of this work is to provide and evaluate a metrically controlled 3D model with very high detail. As shown in Figure 8, useful for direct damage assessment and emergency structural intervention for safety condition, produced with rapid solutions based on aerial acquisition by drone and, wherever possible, with terrestrial close-range images.

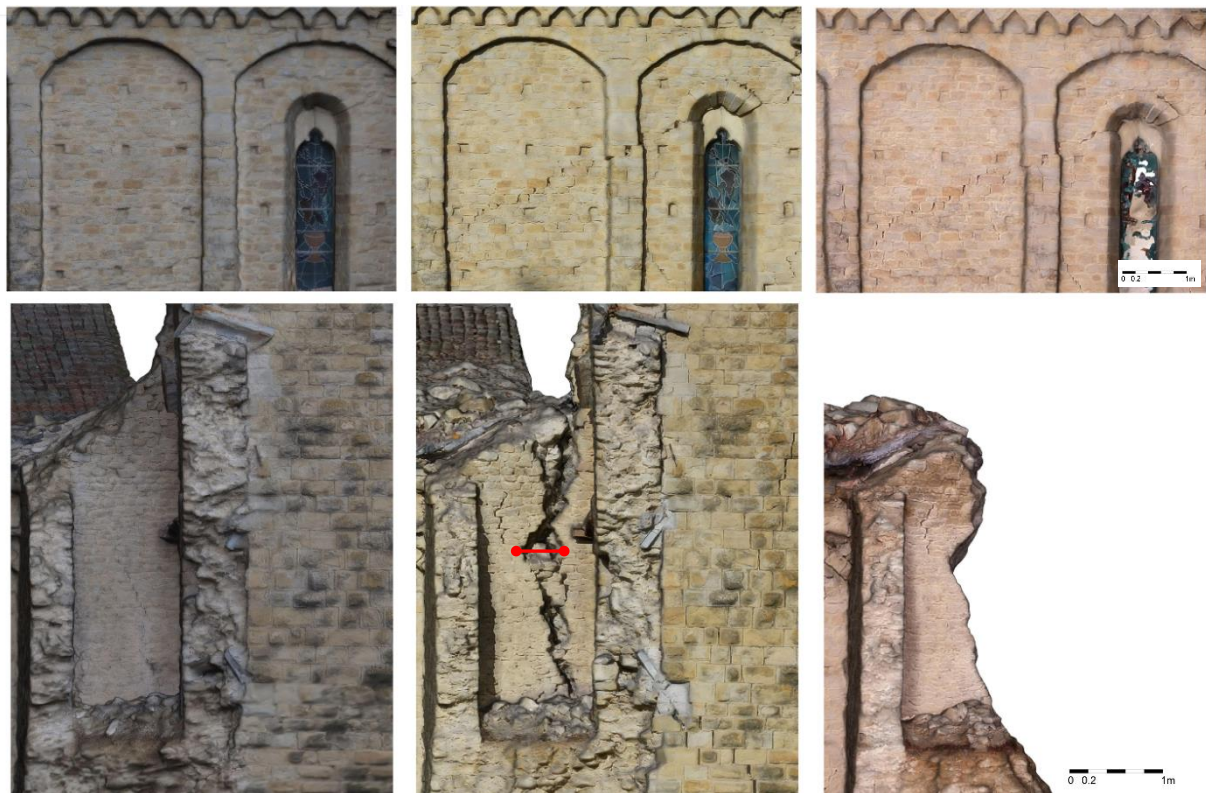
Figure 9. Multi-temporal models and orthoimages excerpts on East wall: (left) t1; (centre) t2; (right) t3

The connection in the South-East corner is maybe one of the most significant enough to be deeply analysed in the global structural behaviour of this ancient masonry. Thanks to the possibility of multi-temporal 3D models comparison (Figure 8) an interesting analysis by orthoimages (Figure 9) and point clouds comparison expressed in range colours classification (Figure 10) can be processed. The orthoimages display great displacements on the masonries connection deformed by shear stress (up to 60cm); here the surface assessment was shown, together with the variation from t1 represented in range scale colours between blue and green. The scale values with the order of magnitude of some centimetres distributed over a mean height of 12m, confirms the serious structural damage that hit the building. Nevertheless, this wall is the only one to be still standing together with a part of the main façade.

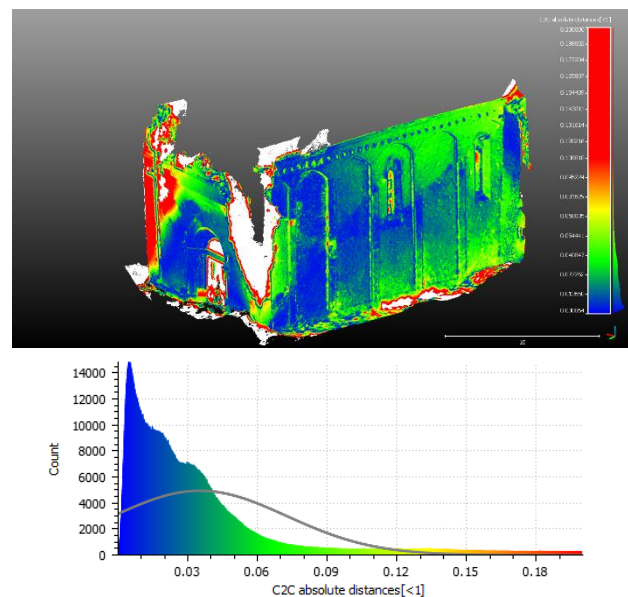
Figure 10. Comparison of t2 on t1 point clouds and associated histogram of values distribution included in $0 < v < 0.2\text{m}$. In grey colours values associated to areas in $T2 > 0.20\text{m}$ respect to T1.

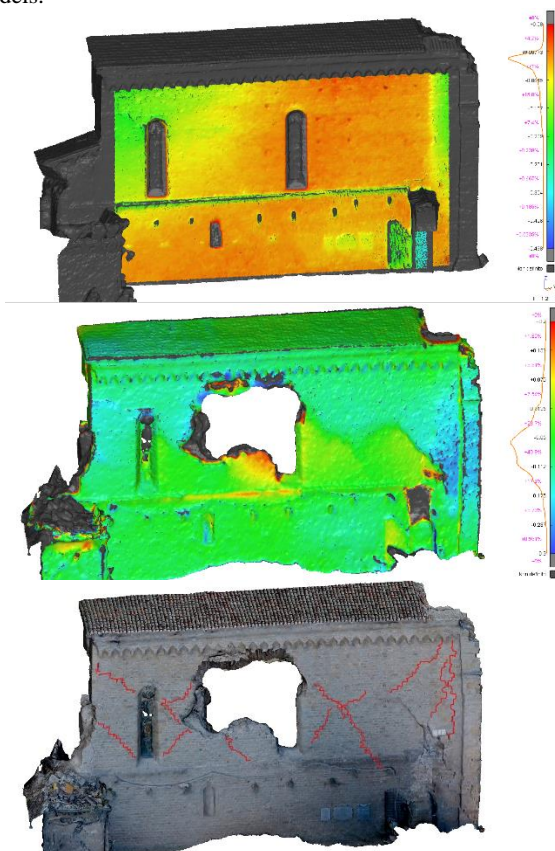
Figure 11. 3D analysis on West wall. a) Fitting plane analysis. b) t1-t2 comparison and mapping c) cracks mapping.

Another focus on the geometric evaluation by multi-temporal comparison that we chose to explore to support masonries stability assessment and contribute to the metric basis for structural diagnosis, is the West wall that, despite the East one, in T3 is not left standing after the subsequent seismic events. On the t1 model it can be traced a widespread lack of planarity of masonry surface (Figure 11a) on the basis on a mean plane fit at the basis on wall. 75% of the surface differs from the vertical plan of about $-0.06\text{m} < v < +0.08\text{m}$. In Figure 11b comparison of t2 on t1 after another seismic event and the collapse of the central area of the wall, in correspondence with the window opening. A series of shear stress traces can be observed, identified and measured with high scale detail on the 3D mesh. A preliminary evaluation of the collapsed volume can be performed too on these kind of models.

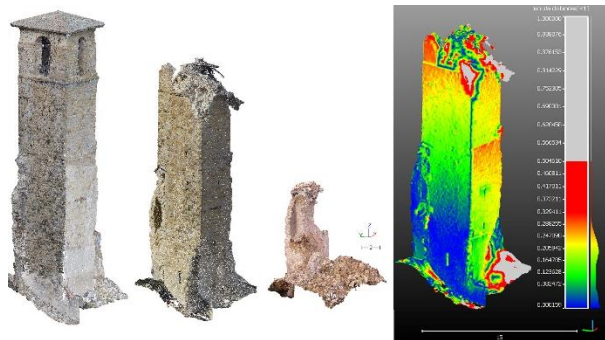
Figure 16. Belfry temporal transformation after reiterated seismic shocks: t1, t2, t3. In range colors comparison between t1-t2 with values $0 < v < 0.50m$ (grey for values $> 0.5m$)

In the 3D metric model of the bell tower, a significant displacement of the north side can be identified, quantifiable in a mean range value of 0.2-0.3m, clearly pinpointed from the slight sliding of bricks layers, in the masonry texture.

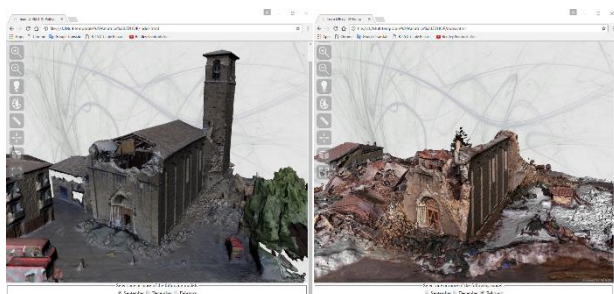
Figure 18. The online 3D HOP visualizer of the multi-temporal model (left, September; right, February)

The models of the three states of evolution were prepared to be shared on a web visualizer through the 3D HOP package. The online visualizer, showed in Figure 18, was customized thanks to the library of available JavaScript functions. The first customization was the addition of a selection tool that allows the users to choose which model or models visualize. In our case we decided to use some tools that allows to perform measurements on the model (distances and coordinates), some tools for the activation of different modalities of visualizations and a tool that enable the creation and management of section planes on different directions.
